**PILLINGS POND DAM**

**MA 00239**

**PHASE I INSPECTION REPORT  
NATIONAL DAM INSPECTION PROGRAM**

**AUGUST 1978**

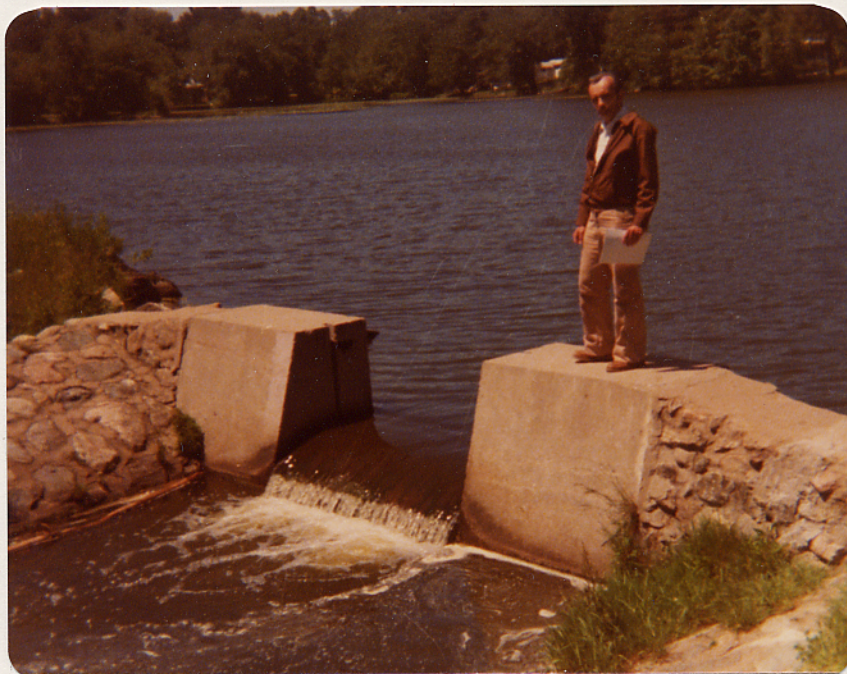
c. Appurtenant Structures. The appurtenant structures comprise a weir, channel and culvert under the dam. The weir is a concrete structure with a 2 foot high by 6.5 foot wide opening with stoplog slots. The weir discharges into a stone-in-mortar channel leading to a concrete culvert under the dam. Apart from minor spalling, the weir is in good condition as is the channel in spite of some growth in the joints. The highway culvert also appears to be in good condition.

Downstream View of Spillway Weir  
from Left Bank

(2) The slots in the spillway structure should be permanently filled in to prevent vandals or unknowledgeable people from placing flashboards in the slots and thus decreasing the flood storage capacity by eliminating the spilling capacity without overtopping.
